B4U Close Inspections Report

**105 Your New Home Boulevard
Lexington KY 40508**

Inspection Date: 9/27/2006
Report ID: Sample Report

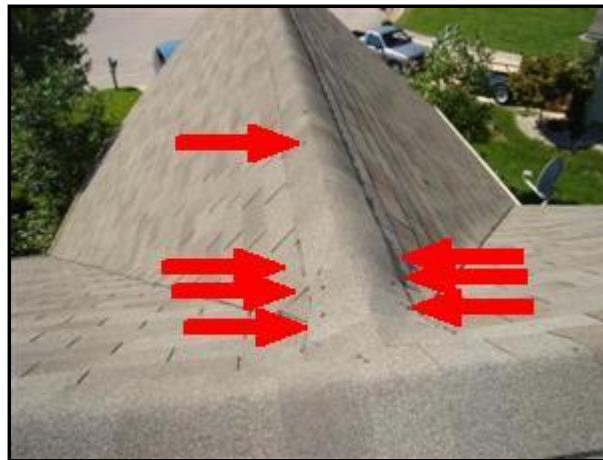
1.0 Picture 1

Comments: Marginal

The ridge shingles at the back of the ridge over the garage have pulled loose from the nails. They need to be replaced.

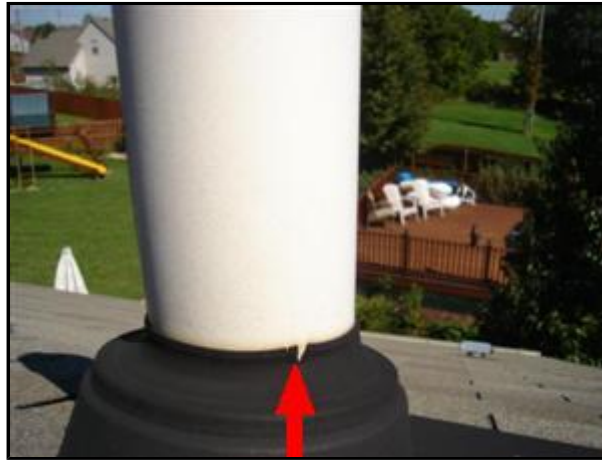
1.3 Picture 1

Comments: Marginal

The rubber boot on the plumbing vent pipe at rear right area is cracked and deteriorated. Repairs by a qualified person are needed to prevent/eliminate leaking around the vent pipe. Caulking is often used as a temporary repair, but the right repair is to replace the boot.

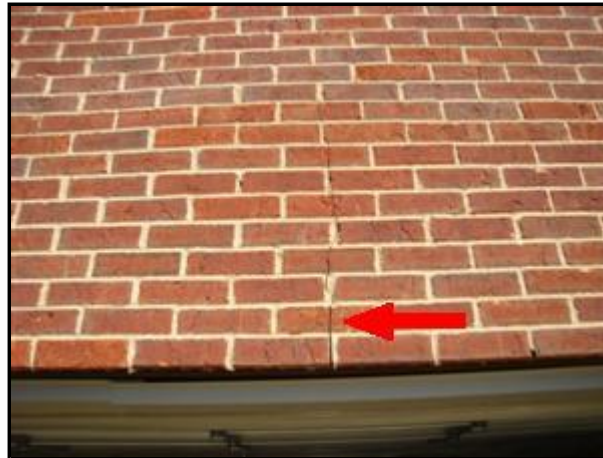
2.0 Picture 1

Comments: Marginal

The brick veneer is cracked over the garage door. The steel lintel (angle iron) may not be large enough to properly support the weight of the brick above it without sagging. Caulking the crack is the only feasible repair without removing the brickwork and replacing the steel lintel with a heavier lintel.

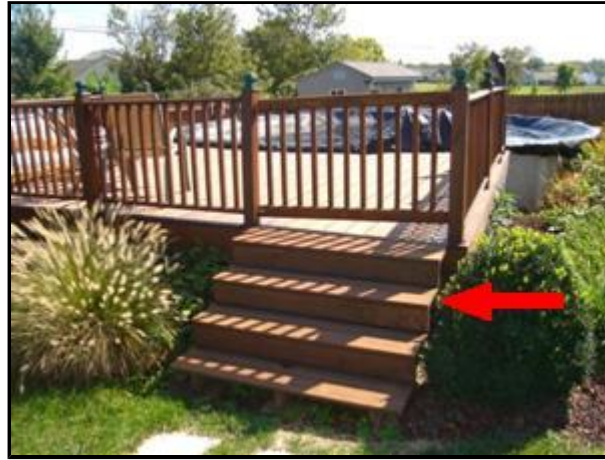
2.3 Picture 1

Comments: Defective

The grippable hand rail / guard rail for the deck steps is missing. The current minimum acceptable safety standards call for a grippable handrail on all staircases with four or more steps. While these steps may have conformed to standards in place at the time of installation, the standards have been upgraded to reflect current generally accepted building practices. These steps may create a risk of personal injury. I recommend a safety upgrade by installing grippable handrails on all staircases with four or more steps.

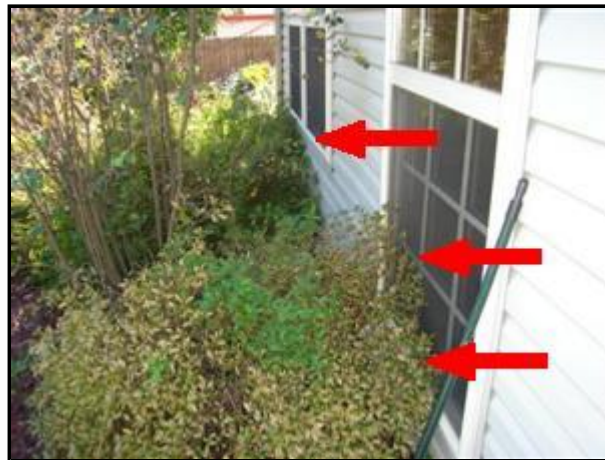
2.4 Picture 1

Comments: Marginal

Shrubs have grown to close to the house and are touching it. Generally accepted building practices recommend 3 inch clearance between shrubs/vegetation and the house to prevent damage to the siding. Recommend vegetation be trimmed to allow a 3" clearance between foliage and structure.

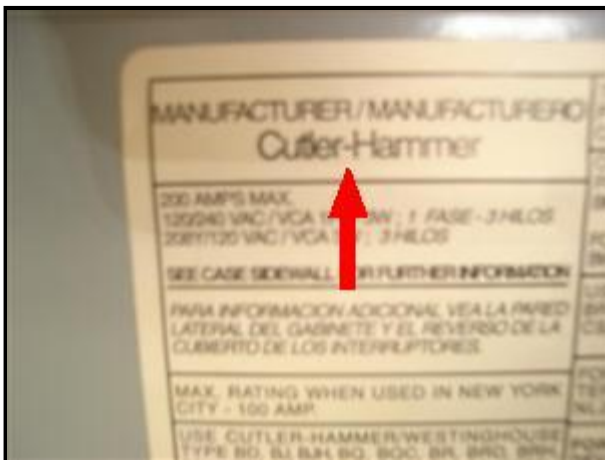
7.1 Picture 1

Comments: Marginal
The problem(s) discovered in the panel such as the mismatched Square D brand breaker in a Cutler Hammer brand panel and any other problems that an electrician may discover while performing repairs need correcting. I recommend a licensed electrician correct as needed.

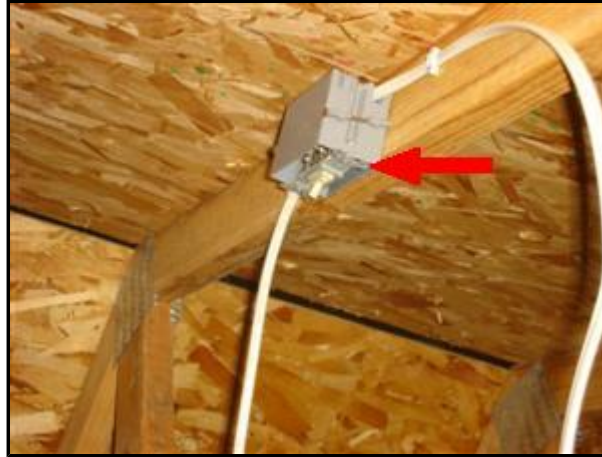
7.2 Picture 1

dwelling's exterior walls)**Comments:** Defective

Cover plate was missing on the switch for the furnace in the attic. Junction/outlet/switch box(es) need covers to prevent sparks from escaping and starting fires. This is a fire hazard that needs repair. Cover plates can usually be purchased at the local hardware store for less than \$1.00. I recommend repair/replacement as needed.

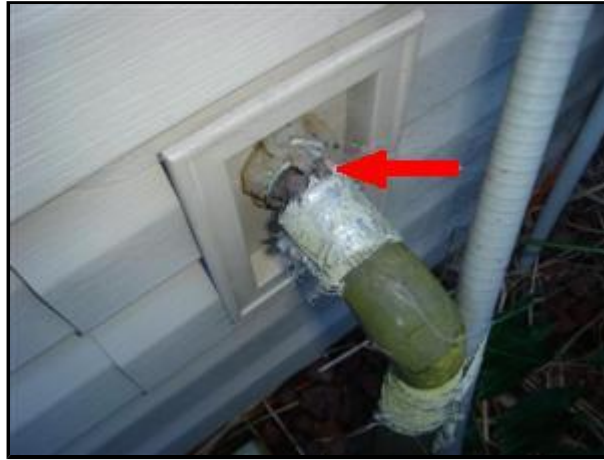
8.2 Picture 1

Comments: Marginal

The insulation on the air conditioning refrigerant line is damaged / deteriorated. It needs repair. Local hardware stores usually stock this insulation in six foot lengths costing about \$2.00.

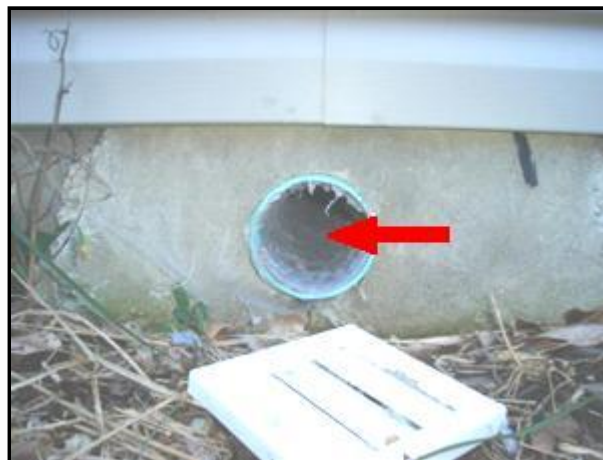
9.3 Picture 1

Comments: Defective

The dryer vent piping needs cleaning. Excessive lint build up is a fire hazard. All vent pipes should be cleaned regularly, especially if they are longer than normal (10 feet or more) or vented vertically. I recommend cleaning as needed.

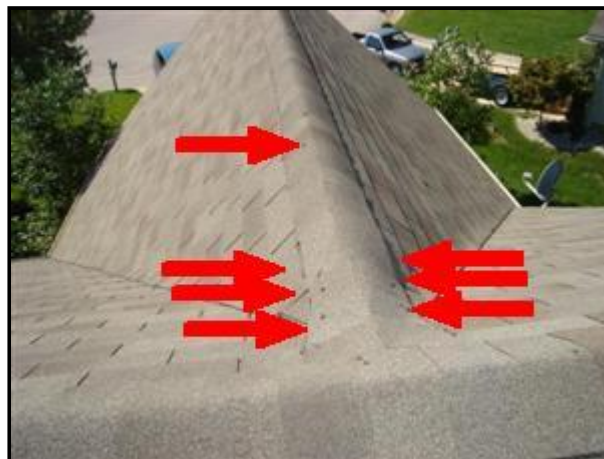
1.0 Picture 1

Marginal

The ridge shingles at the back of the ridge over the garage have pulled loose from the nails. They need to be replaced.

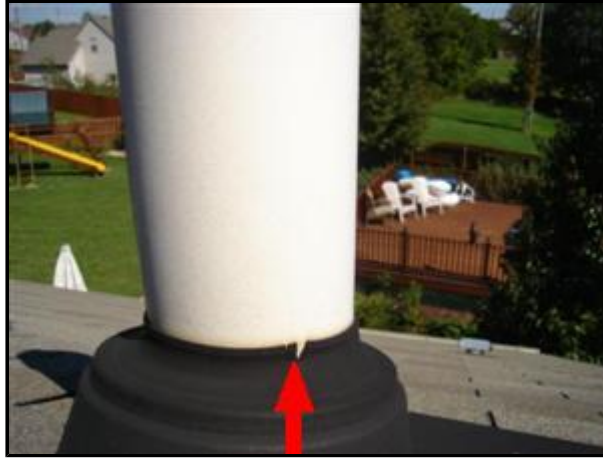
1.3 Picture 1

The rubber boot on the plumbing vent pipe at rear right area is cracked and deteriorated. Repairs by a

qualified person are needed to prevent/eliminate leaking around the vent pipe. Caulking is often used as a temporary repair, but the right repair is to replace the boot.

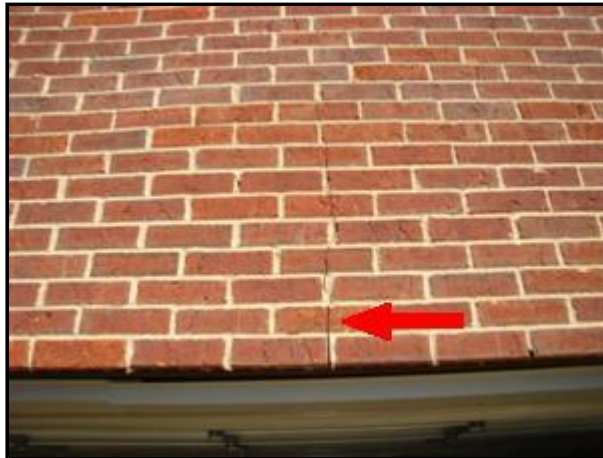
2.0 Picture 1

Marginal

The brick veneer is cracked over the garage door. The steel lintel (angle iron) may not be large enough to properly support the weight of the brick above it without sagging. Caulking the crack is the only feasible repair without removing the brickwork and replacing the steel lintel with a heavier lintel.

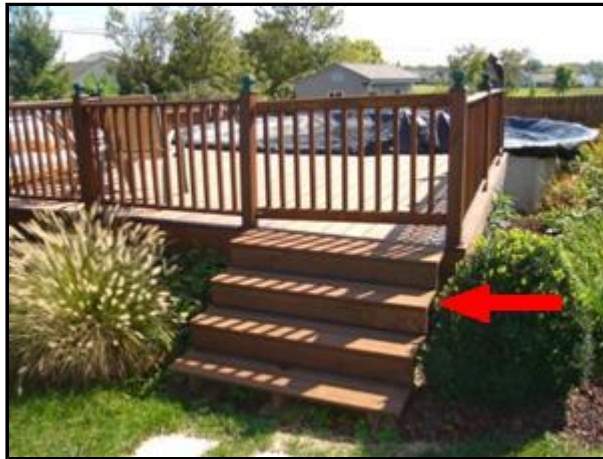
2.3 Picture 1

Defective

The grippable hand rail / guard rail for the deck steps is missing. The current minimum acceptable safety standards call for a grippable handrail on all staircases with four or more steps. While these steps may have conformed to standards in place at the time of installation, the standards have been upgraded to reflect current generally accepted building practices. These steps may create a risk of personal injury. I recommend a safety upgrade by installing grippable handrails on all staircases with four or more steps.

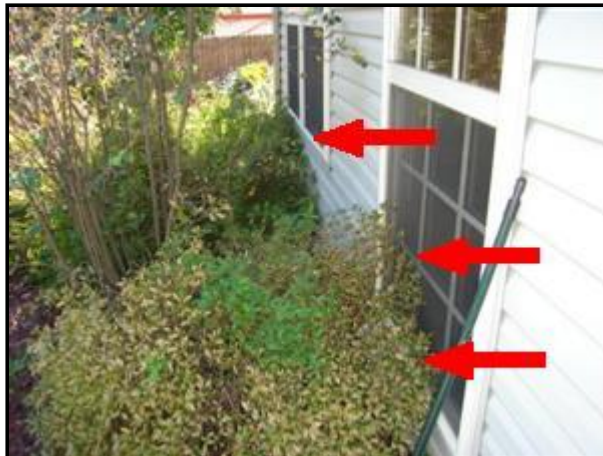
2.4 Picture 1

Marginal

Shrubs have grown to close to the house and are touching it. Generally accepted building practices recommend 3 inch clearance between shrubs/vegetation and the house to prevent damage to the siding. Recommend vegetation be trimmed to allow a 3" clearance between foliage and structure.

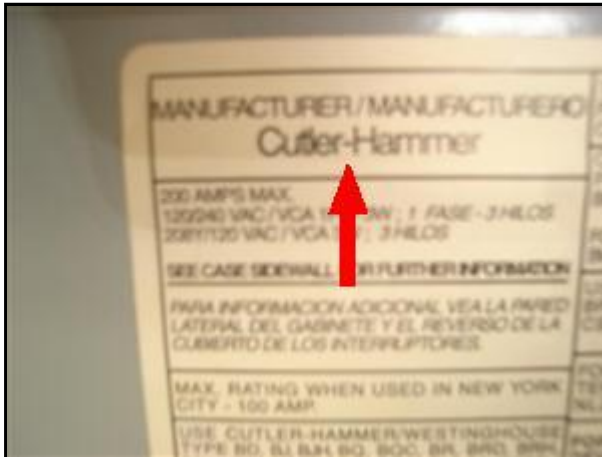
7.1 Picture 1

The problem(s) discovered in the panel such as the mismatched Square D brand breaker in a Cutler Hammer brand panel and any other problems that an electrician may discover while performing repairs need correcting. I recommend a licensed electrician correct as needed.

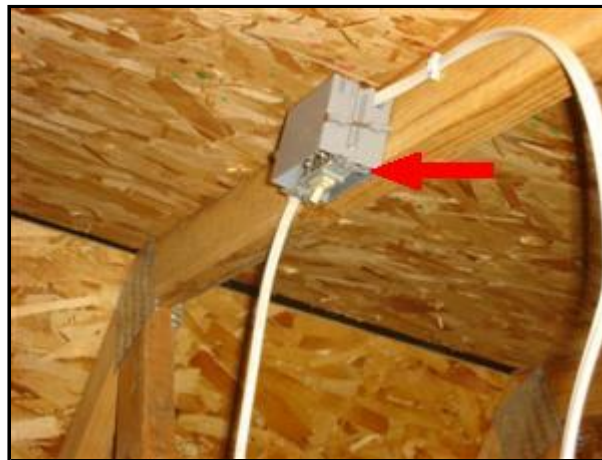
7.2 Picture 1

Defective

Cover plate was missing on the switch for the furnace in the attic. Junction/outlet/switch box(es) need covers to prevent sparks from escaping and starting fires. This is a fire hazard that needs repair. Cover plates can usually be purchased at the local hardware store for less than \$1.00. I recommend repair/replacement as needed.

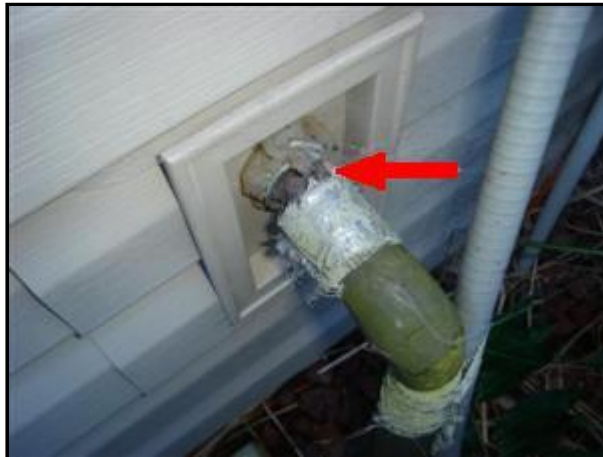
8.2 Picture 1

The insulation on the air conditioning refrigerant line is damaged / deteriorated. It needs repair. Local hardware stores usually stock this insulation in six foot lengths costing about \$2.00.

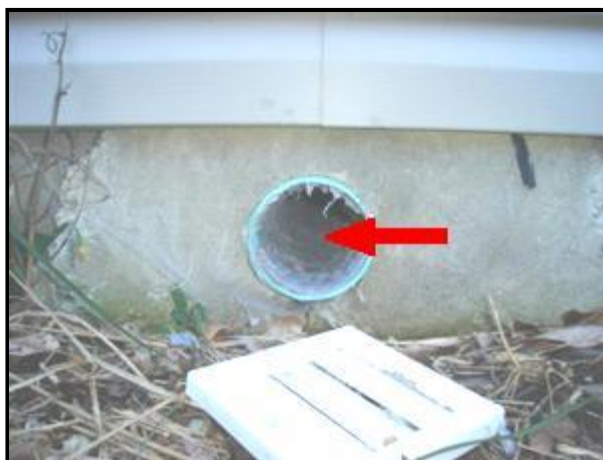
9.3 Picture 1

Defective

The dryer vent piping needs cleaning. Excessive lint build up is a fire hazard. All vent pipes should be cleaned regularly, especially if they are longer than normal (10 feet or more) or vented vertically. I recommend cleaning as needed.
