B4U Close Inspections Report

**105 Your New Home Boulevard
Lexington KY 40508**

Erby Crofutt, Inspector
KY Lic#: HI-2041

Inspection Date: 9/27/2006
Report ID: Sample Report

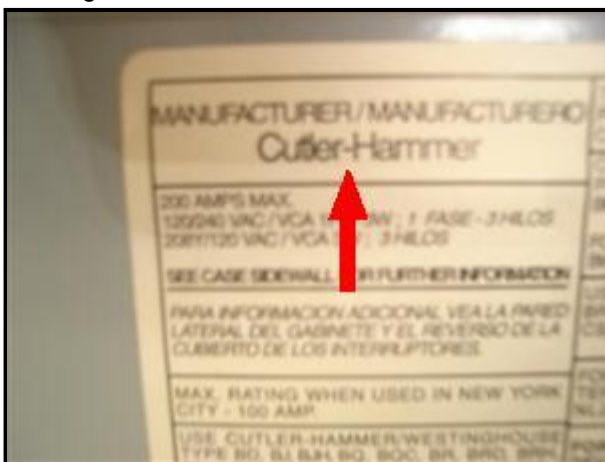
7.1 Picture 1

Comments: Marginal
The problem(s) discovered in the panel such as the mismatched Square D brand breaker in a Cutler Hammer brand panel and any other problems that an electrician may discover while performing repairs need correcting. I recommend a licensed electrician correct as needed.

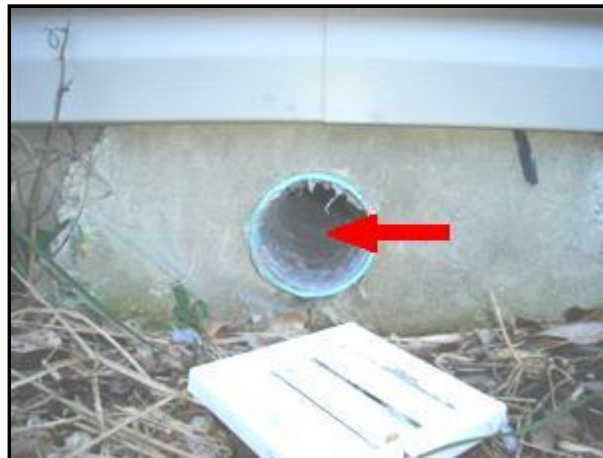
9.3 Picture 1

Comments: Defective

The dryer vent piping needs cleaning. Excessive lint build up is a fire hazard. All vent pipes should be cleaned regularly, especially if they are longer than normal (10 feet or more) or vented vertically. I recommend cleaning as needed.

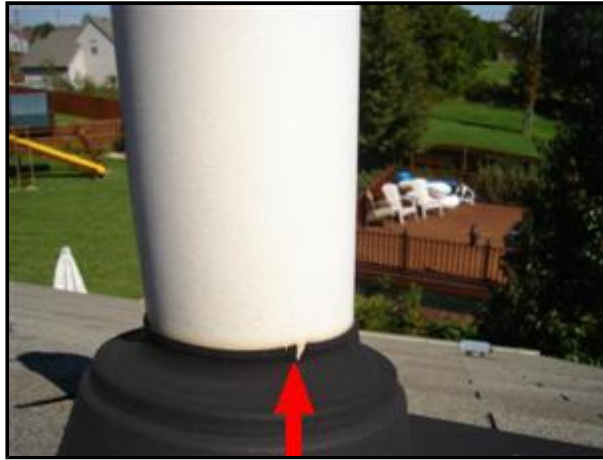
1.3 Picture 1

The rubber boot on the plumbing vent pipe at rear right area is cracked and deteriorated. Repairs by a

qualified person are needed to prevent/eliminate leaking around the vent pipe. Caulking is often used as a temporary repair, but the right repair is to replace the boot.

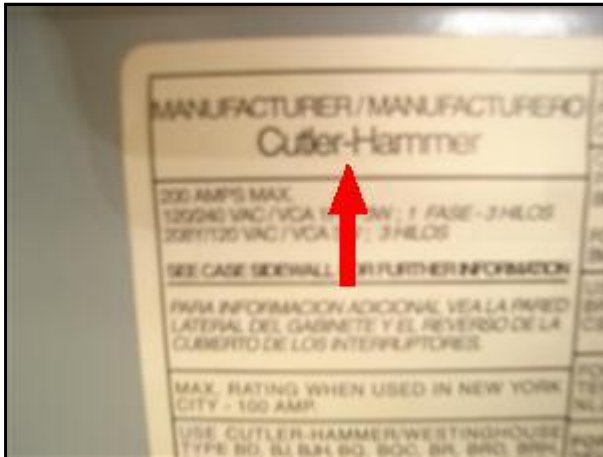
7.1 Picture 1

The problem(s) discovered in the panel such as the mismatched Square D brand breaker in a Cutler Hammer brand panel and any other problems that an electrician may discover while performing repairs need correcting. I recommend a licensed electrician correct as needed.

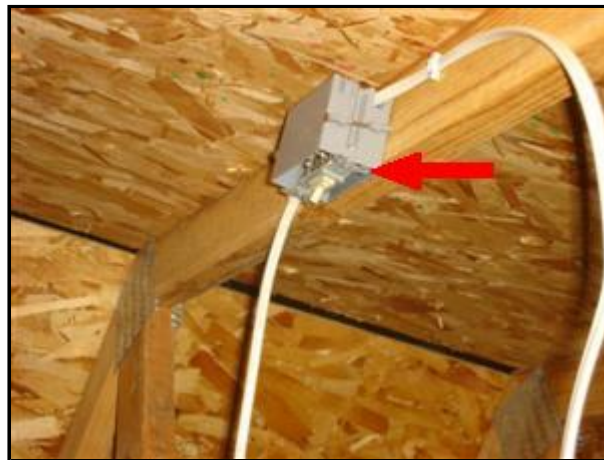
7.2 Picture 1

Defective

Cover plate was missing on the switch for the furnace in the attic. Junction/outlet/switch box(es) need covers to prevent sparks from escaping and starting fires. This is a fire hazard that needs repair. Cover plates can usually be purchased at the local hardware store for less than \$1.00. I recommend repair/replacement as needed.

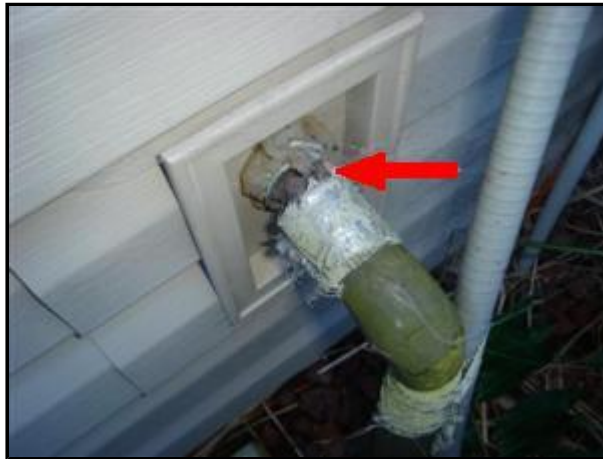
8.2 Picture 1

The insulation on the air conditioning refrigerant line is damaged / deteriorated. It needs repair. Local hardware stores usually stock this insulation in six foot lengths costing about \$2.00.

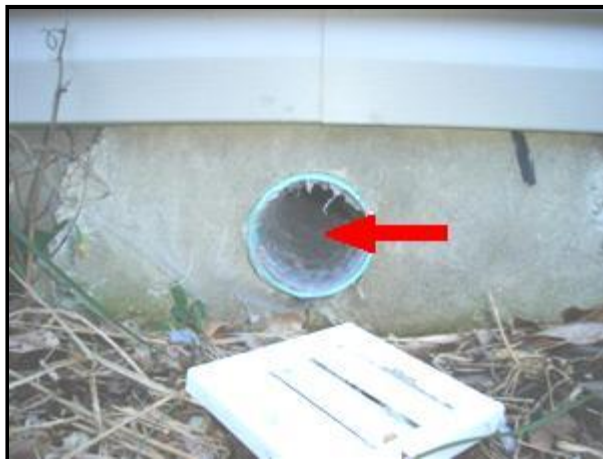
9.3 Picture 1

Defective

The dryer vent piping needs cleaning. Excessive lint build up is a fire hazard. All vent pipes should be cleaned regularly, especially if they are longer than normal (10 feet or more) or vented vertically. I recommend cleaning as needed.
