B4U Close Inspections Report

**105 Your New Home Boulevard
Lexington KY 40508**

Erby Crofutt, Inspector
KY Lic#: HI-2041

Inspection Date: 9/27/2006
Report ID: Sample Report

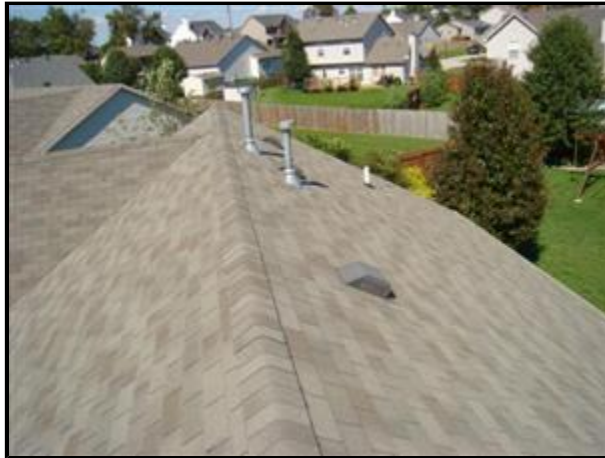
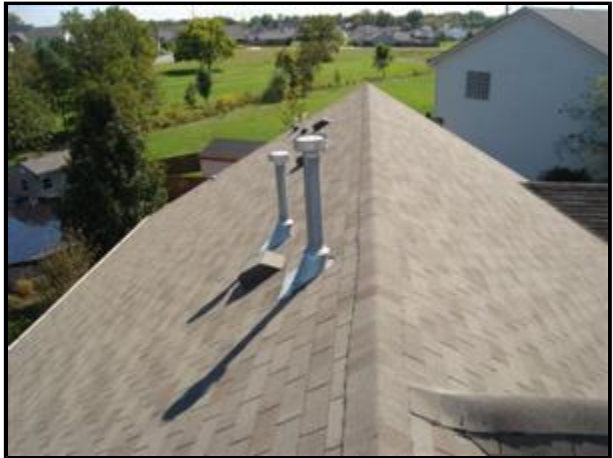
The ridge shingles at the back of the ridge over the garage have pulled loose from the nails. They need to be replaced.

The rubber boot on the plumbing vent pipe at rear right area is cracked and deteriorated. Repairs by a qualified person are needed to prevent/eliminate leaking around the vent pipe. Caulking is often used as a temporary repair, but the right repair is to replace the boot.

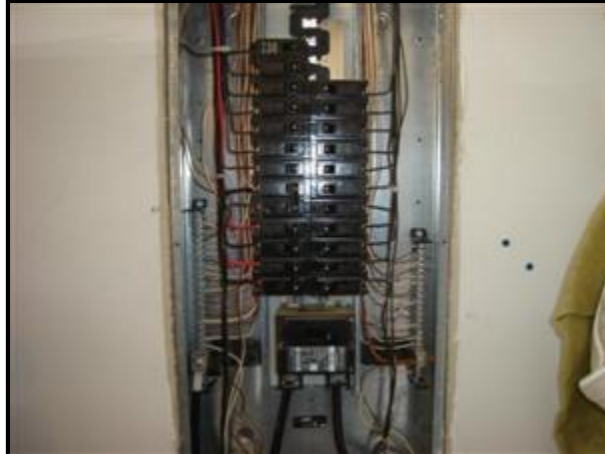
Comments: Marginal
The problem(s) discovered in the panel such as the mismatched Square D brand breaker in a Cutler Hammer brand panel and any other problems that an electrician may discover while performing repairs need correcting. I recommend a licensed electrician correct as needed.

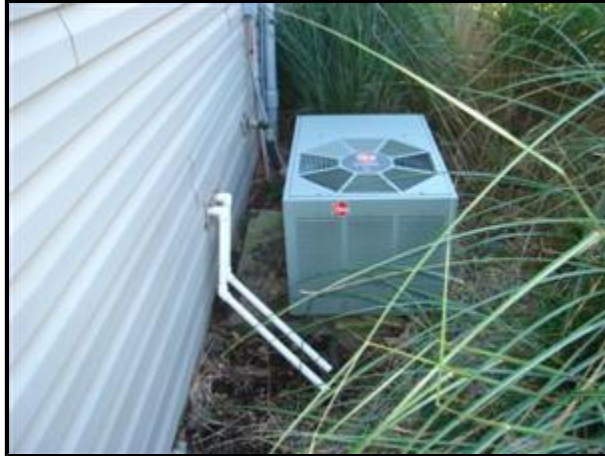
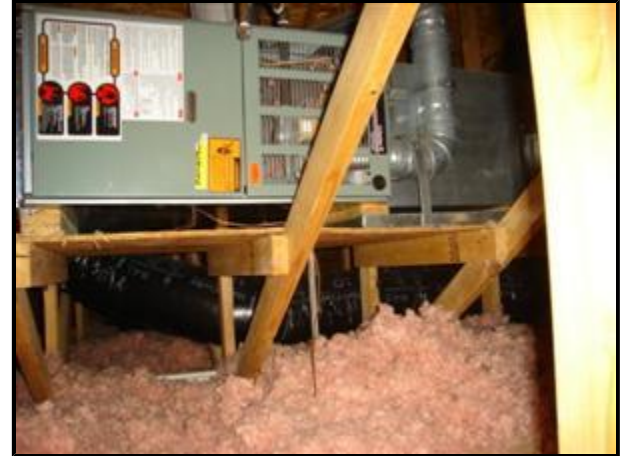
The insulation on the air conditioning refrigerant line is damaged / deteriorated. It needs repair. Local hardware stores usually stock this insulation in six foot lengths costing about \$2.00.

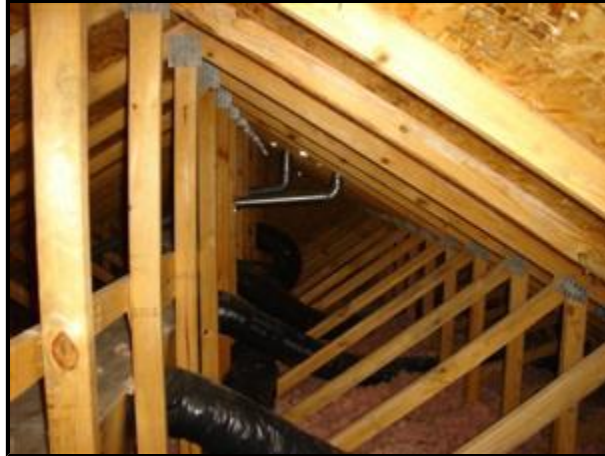
The dryer vent piping needs cleaning. Excessive lint build up is a fire hazard. All vent pipes should be cleaned regularly, especially if they are longer than normal (10 feet or more) or vented vertically. I recommend cleaning as needed.

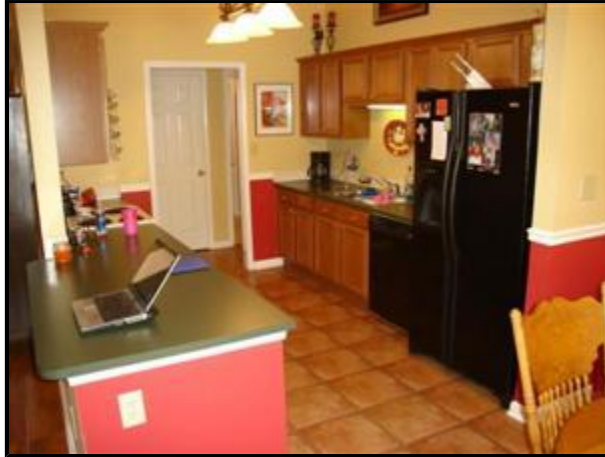
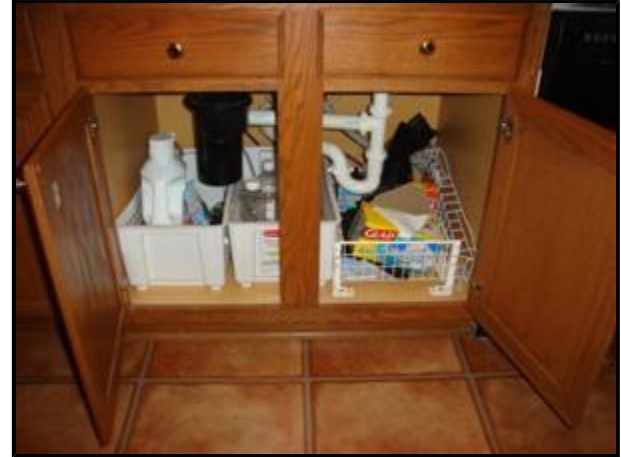
Anti-tip device not installed to keep the stove from tipping over when children climb on or weight is placed on the oven door. I recommend that one be installed for safety. They typically only cost a few dollars at a local hardware store. Otherwise, the stove operated acceptably. See warning label on oven door.

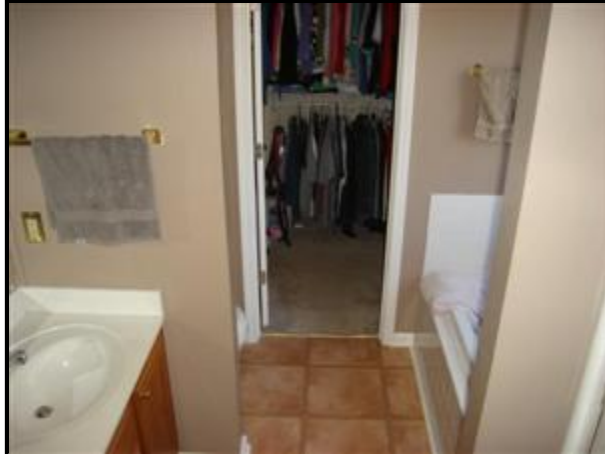
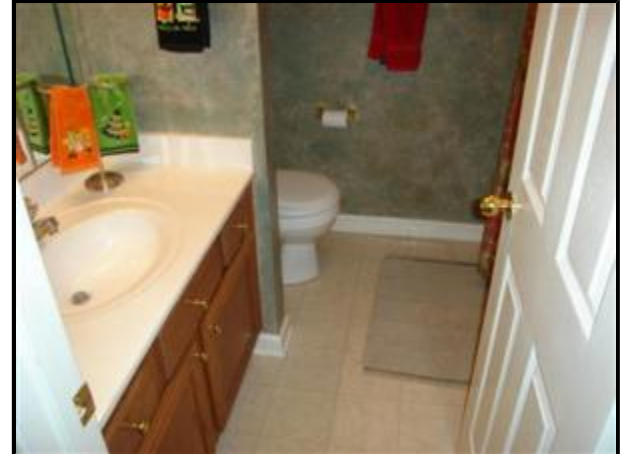
The tub in the hall bath drains slowly. Functional flow of the drain is inadequate. I recommend that the drain be cleaned.
